Manhole Inspection Summary

Manhole # S21KK_043MH

Location Address: **1925 FULTON AVE**

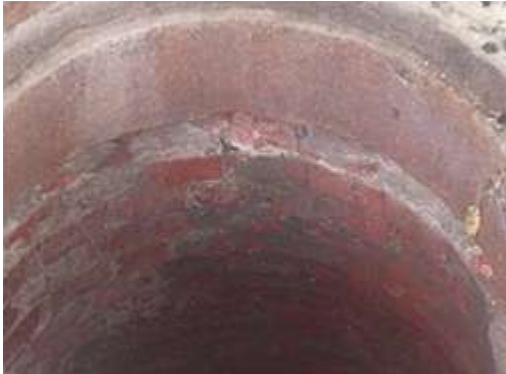
Defect 2

Condition: ☐ Sound ☐ Cracked ☐ Root Intrusion ☐ Loose Brick ☒ **Deteriorated**

DETERIORATION OF CHIMNEY

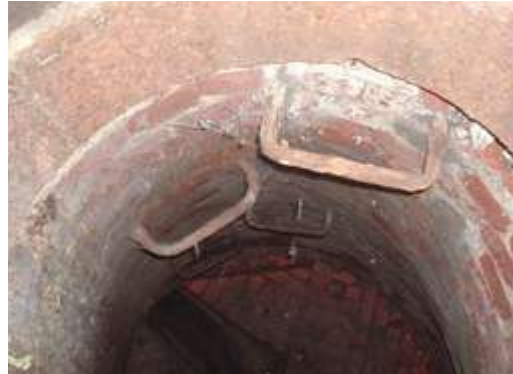
Defect 1

Steps Count: **4** Missing: **0** ☒ **Corroded**

CORRODED STEPS

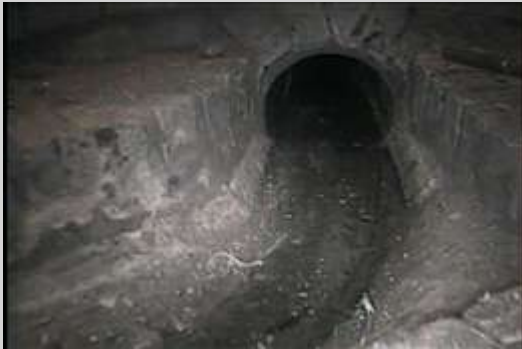
12 O'Clock Outflow

Pipe Height: **8.4** (in.) Rod and Bar (Angled)
Pipe Material: **Clay** ☐ Pipe Lined
Invert Depth: **7.51** (ft.) Flow Characteristics: **Slow**
Deposits: ☒ None ☐ Mud ☐ Sludge ☐ Debris ☐ Grease
Silt Depth: (in.) Deposits Extent:
Infiltration: **None** Pipe Seal Cond: **Sound**

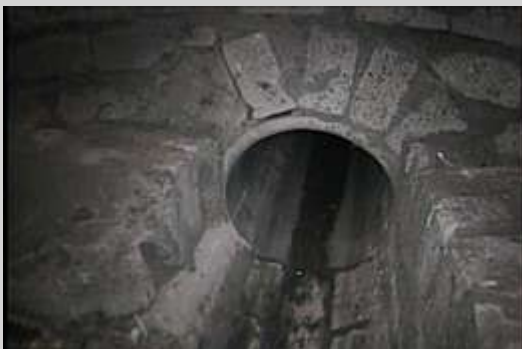
6 O'Clock Inflow

Pipe Height: **8.4** (in.) Rod and Bar (Angled)
Pipe Material: **Clay** ☐ Pipe Lined
Invert Depth: **7.25** (ft.) Flow Characteristics: **None**
Deposits: ☒ None ☐ Mud ☐ Sludge ☐ Debris ☐ Grease
Silt Depth: (in.) Deposits Extent:
Infiltration: **None** Pipe Seal Cond: **Sound**

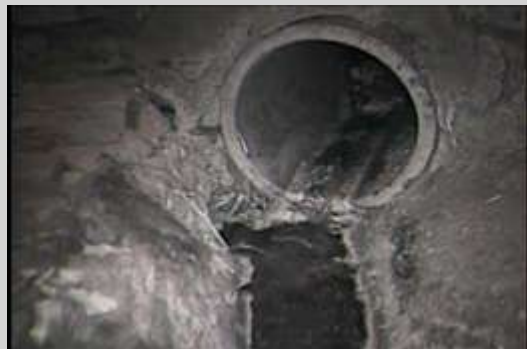
8 O'Clock Inflow

Invert Depth: **7.44** (ft.) Flow Characteristics: **Slow**

Infiltration: **None** Pipe Seal Cond: **Sound**
